# Manhole Inspection Summary

Manhole # S13II\_002MH

Insp Date: **2/23/09 3:34 PM**

**Location** Address: **REAR 1720 DUKELAND ST**

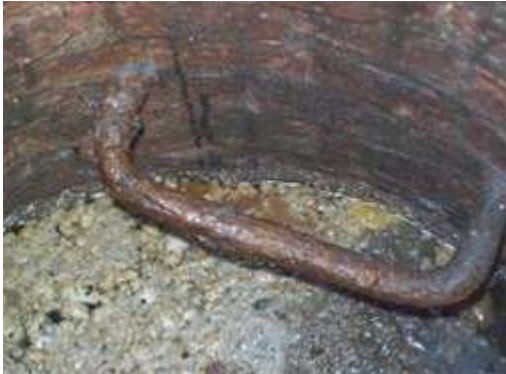
Defect 1

CORRODED STEP

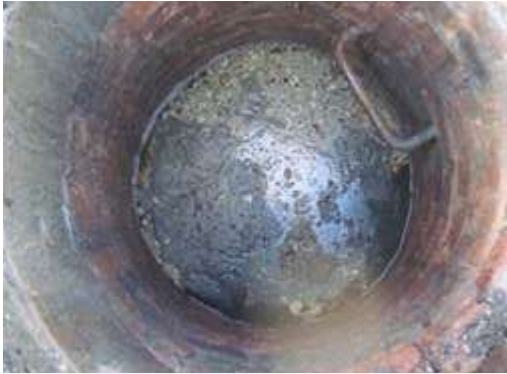
Defect 2

**Surcharge** ☒ **Evidence Of Surcharge** Depth: **4** (ft.) ☐ Active Surcharge Present

ASUR

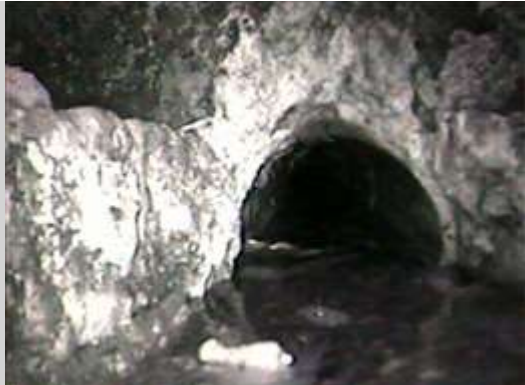
12 O'Clock Outflow

8 in. Circular Gravity Sewer  
Pipe Out @ 12 O'Clock

Pipe Material: **Clay** ☐ Pipe Lined

Invert Depth: **9.22** (ft.) Flow Characteristics: **Slow**

Infiltration: **None** Pipe Seal Cond: **Unknown**

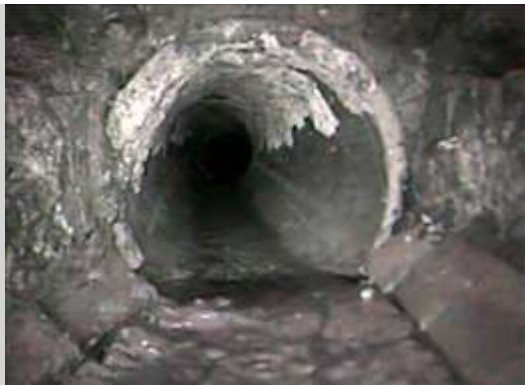
3 O'Clock Inflow

8 in. Circular Gravity Sewer  
Pipe In @ 3 O'Clock

Pipe Material: **Clay** ☐ Pipe Lined

Invert Depth: **9.09** (ft.) Flow Characteristics: **Slow**

Infiltration: **None** Pipe Seal Cond: **Sound**

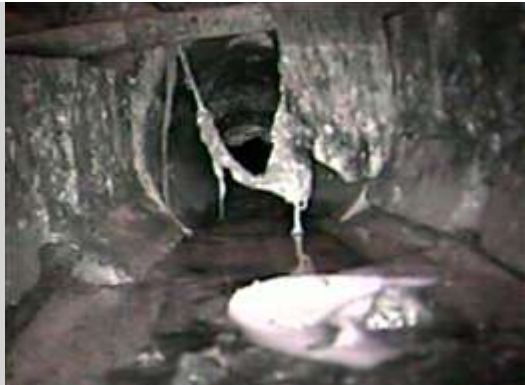
6 O'Clock Inflow

8 in. Circular Gravity Sewer

Pipe In @ 6 O'Clock

Pipe Material: **Clay** ☐ Pipe Lined

Invert Depth: **9.06** (ft.) Flow Characteristics: **Slow**

Infiltration: **None** Pipe Seal Cond: **Unknown**

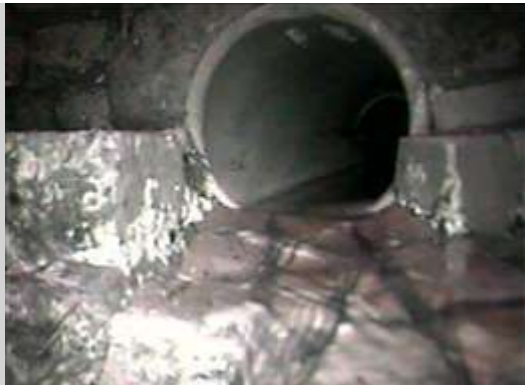
9 O'Clock Inflow

8 in. Circular Gravity Sewer

Pipe In @ 9 O'Clock

Pipe Material: **Clay** ☐ Pipe Lined

Invert Depth: **8.73** (ft.) Flow Characteristics: **Slow**

Infiltration: **None** Pipe Seal Cond: **Sound**
